Ice/Frost/Debris Assessment For Space Shuttle Mission STS-27R

(NASA-TM-102144) ICE/FROST/DEBRIS
ASSESSMENT FOR SPACE SHUTTLE MISSION
STS-27R, DECEMBER 2, 1988 (NASA) 200 p
CSCI 22B

ICE/FROST/DEBRIS ASSESSMENT
FOR
SPACE SHUTTLE MISSION
STS-27R
DECEMBER 2, 1988

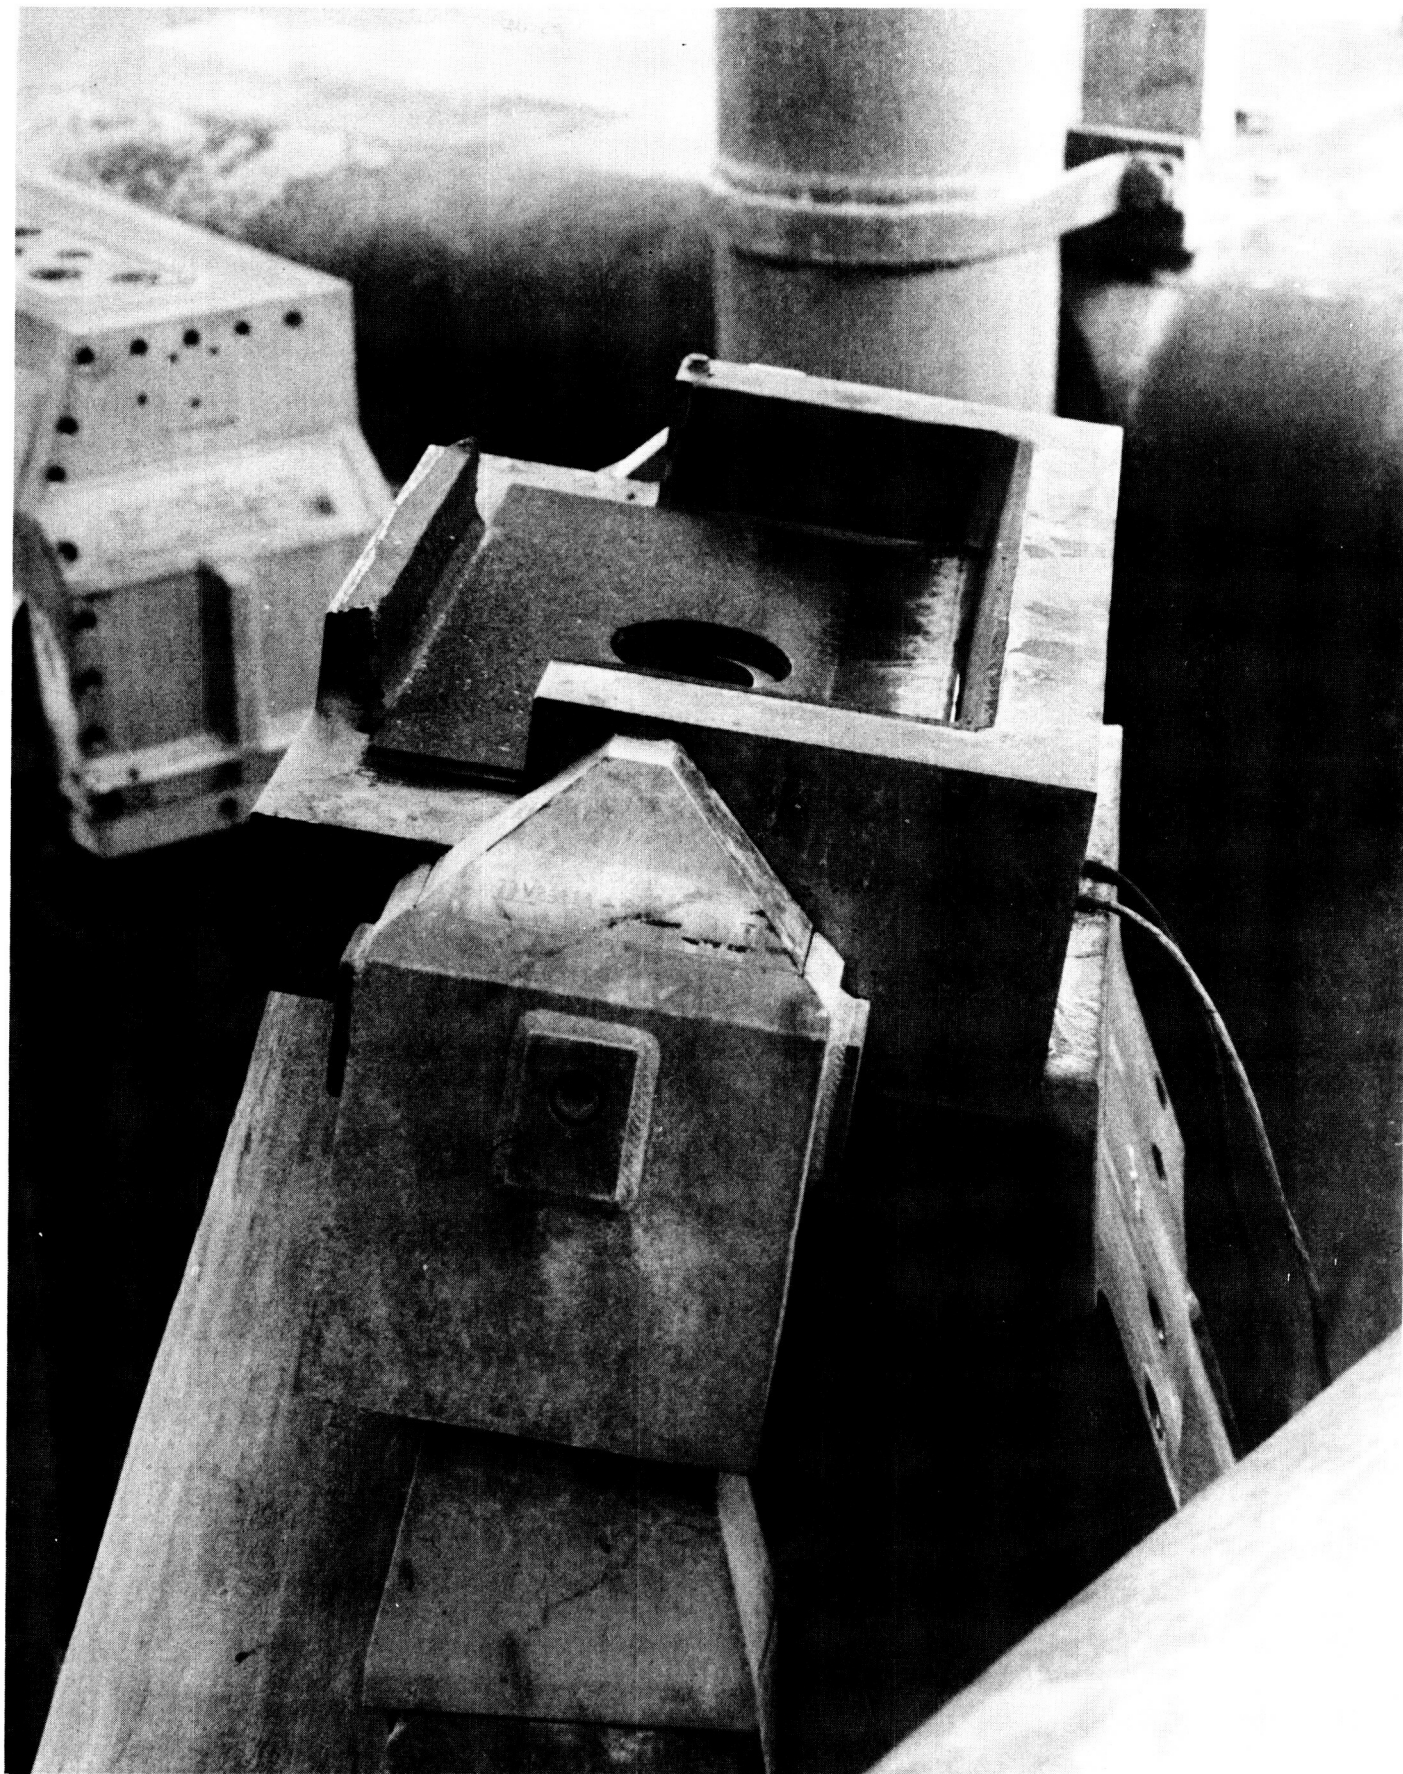
HOLDDOWN POST #5 (LH SRB SE CORNER) EXHIBITING NO
POST LAUNCH DAMAGE. CORNER OF SHIM IS DEBONDED.

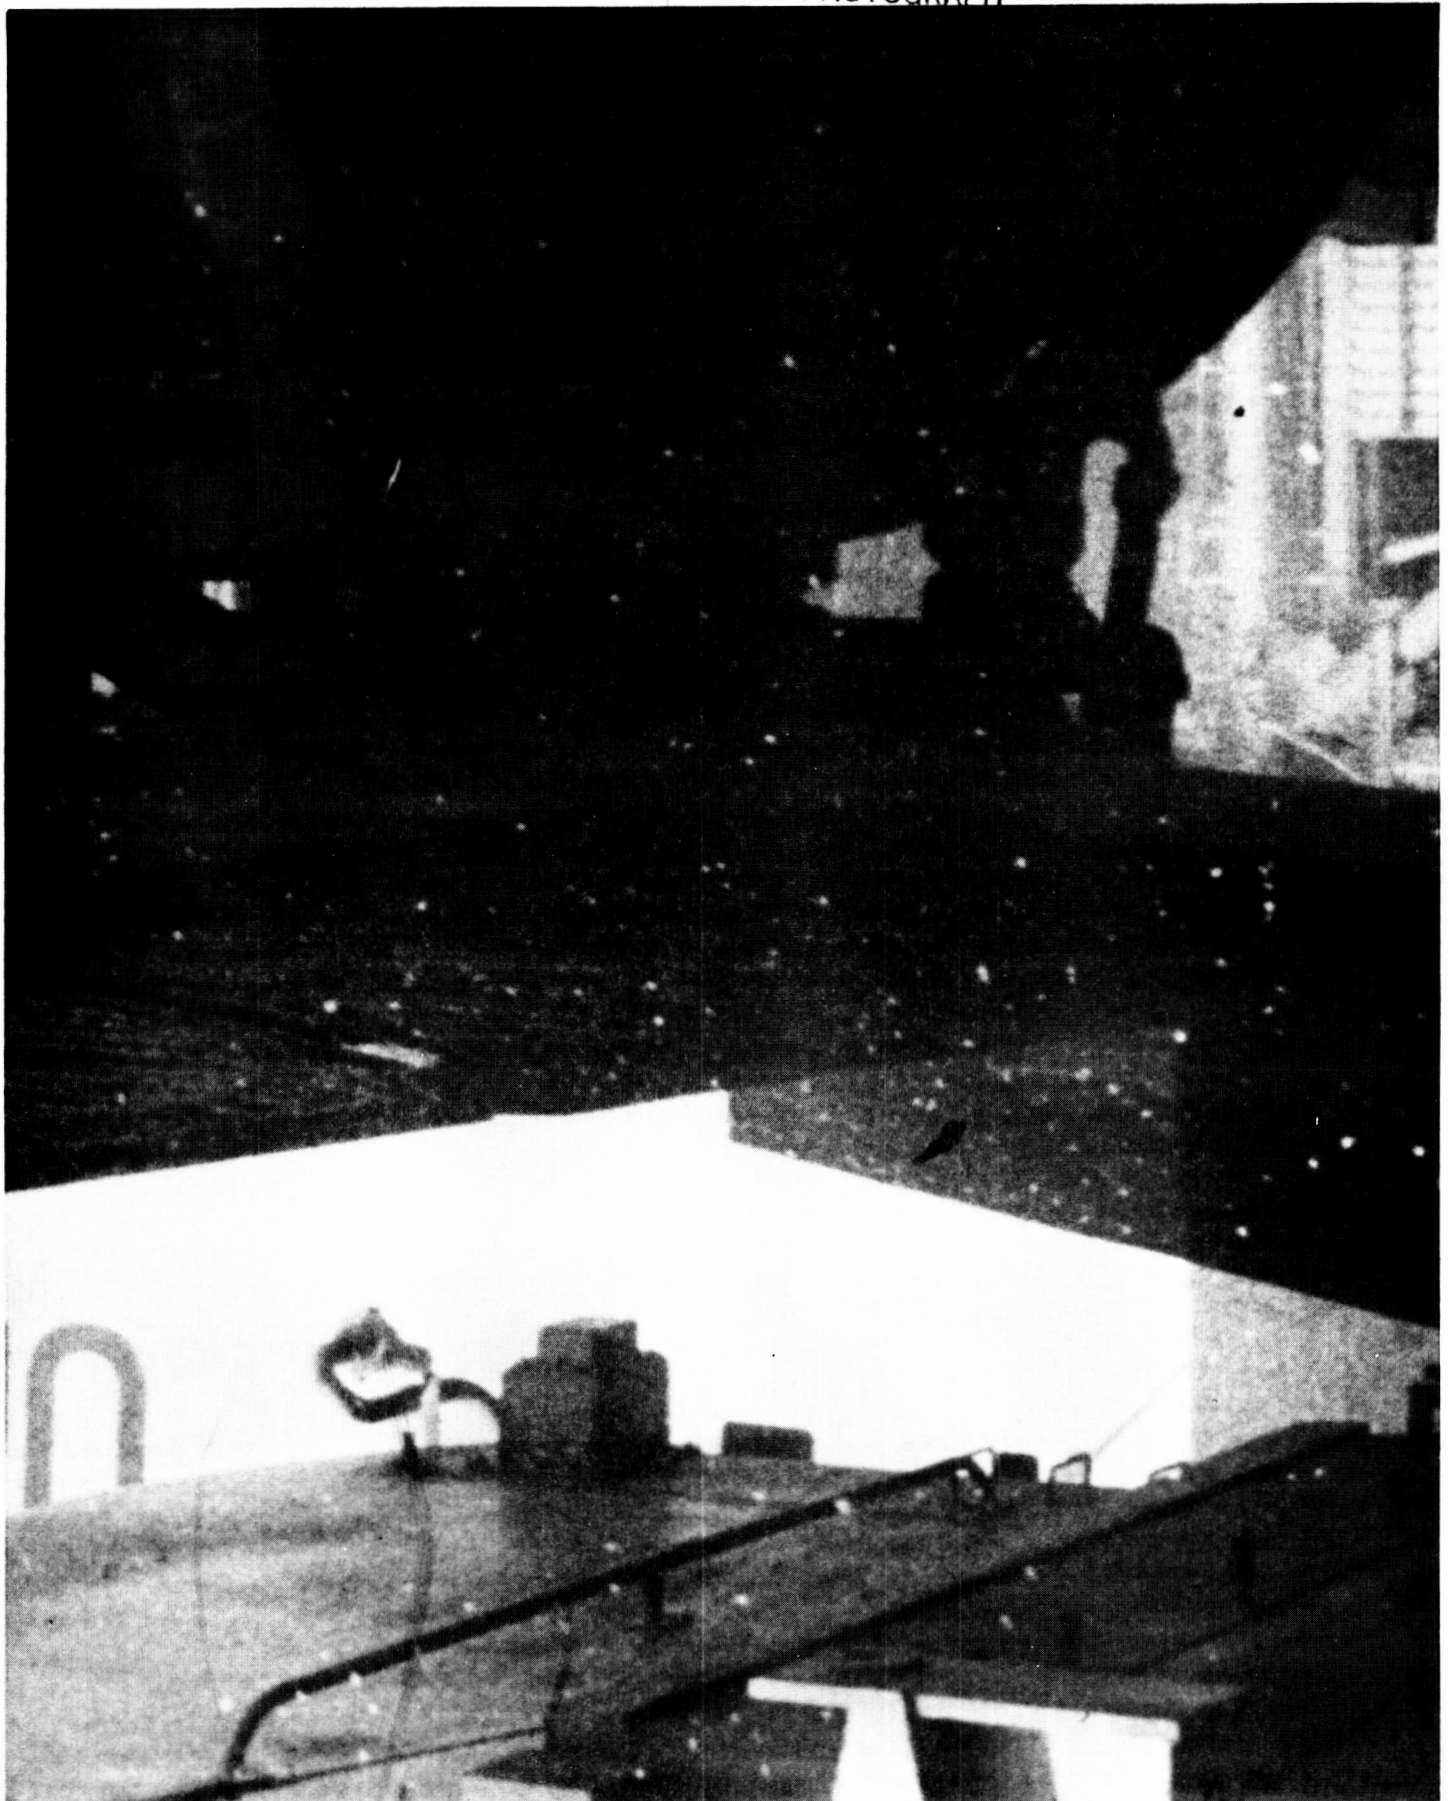
FILM ITEM E-6. ICE/FROST PARTICLES FALL FROM UMBILICALS AND
"BRUSH" AGAINST RH INBOARD ELEVON. NO VISIBLE TPS DAMAGE.

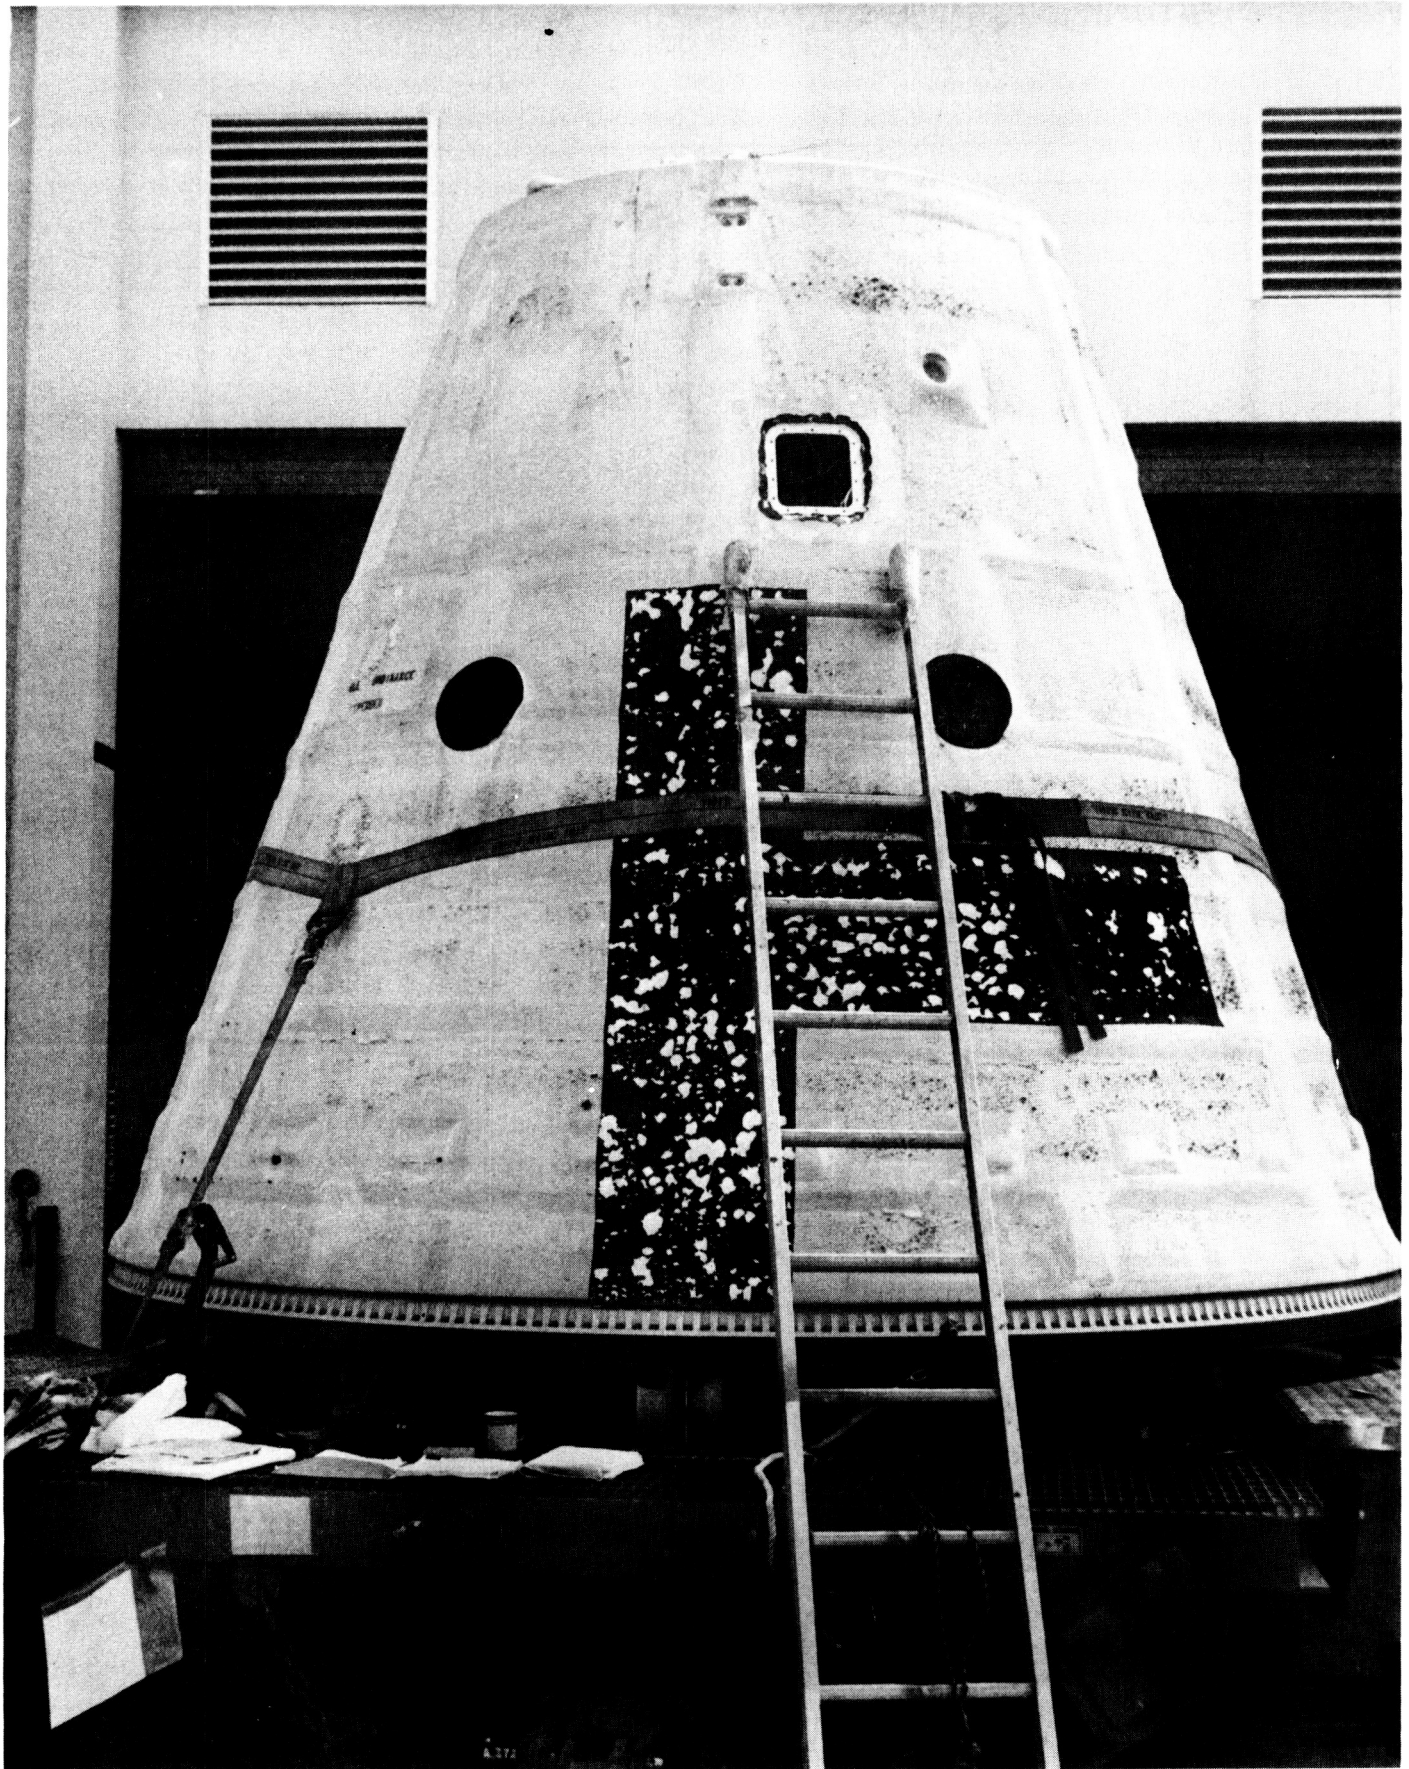
HYPALON PAINT BLISTERING ON LH SRB FRUSTUM

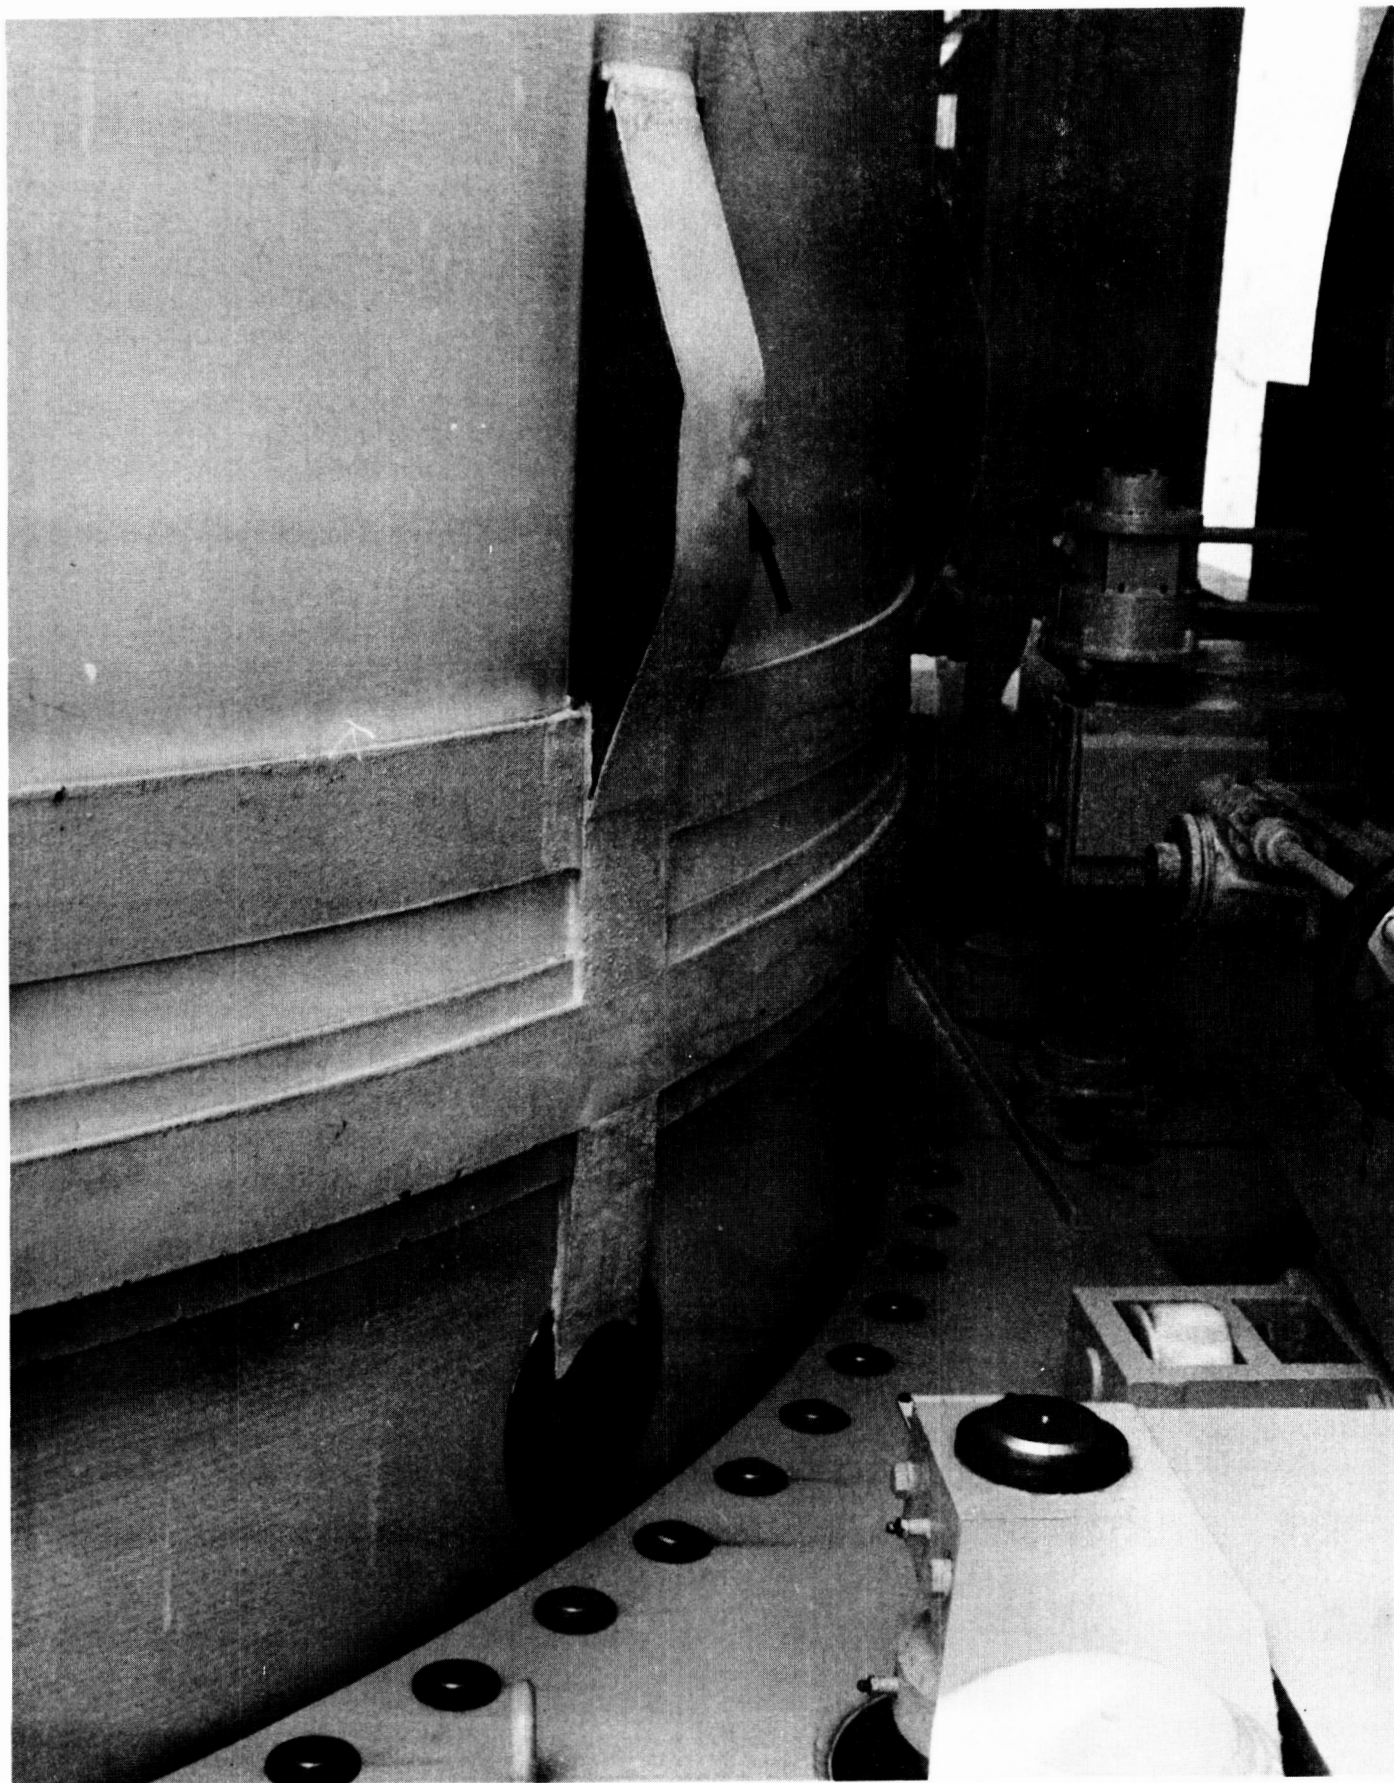
1-INCH DIAMETER DEBOND (NO MISSING MATERIAL) ON OUTBOARD FACE
OF THE PRESSURE TRANSDUCER CORK RAMP ON THE LH FWD SRB SEGMENT

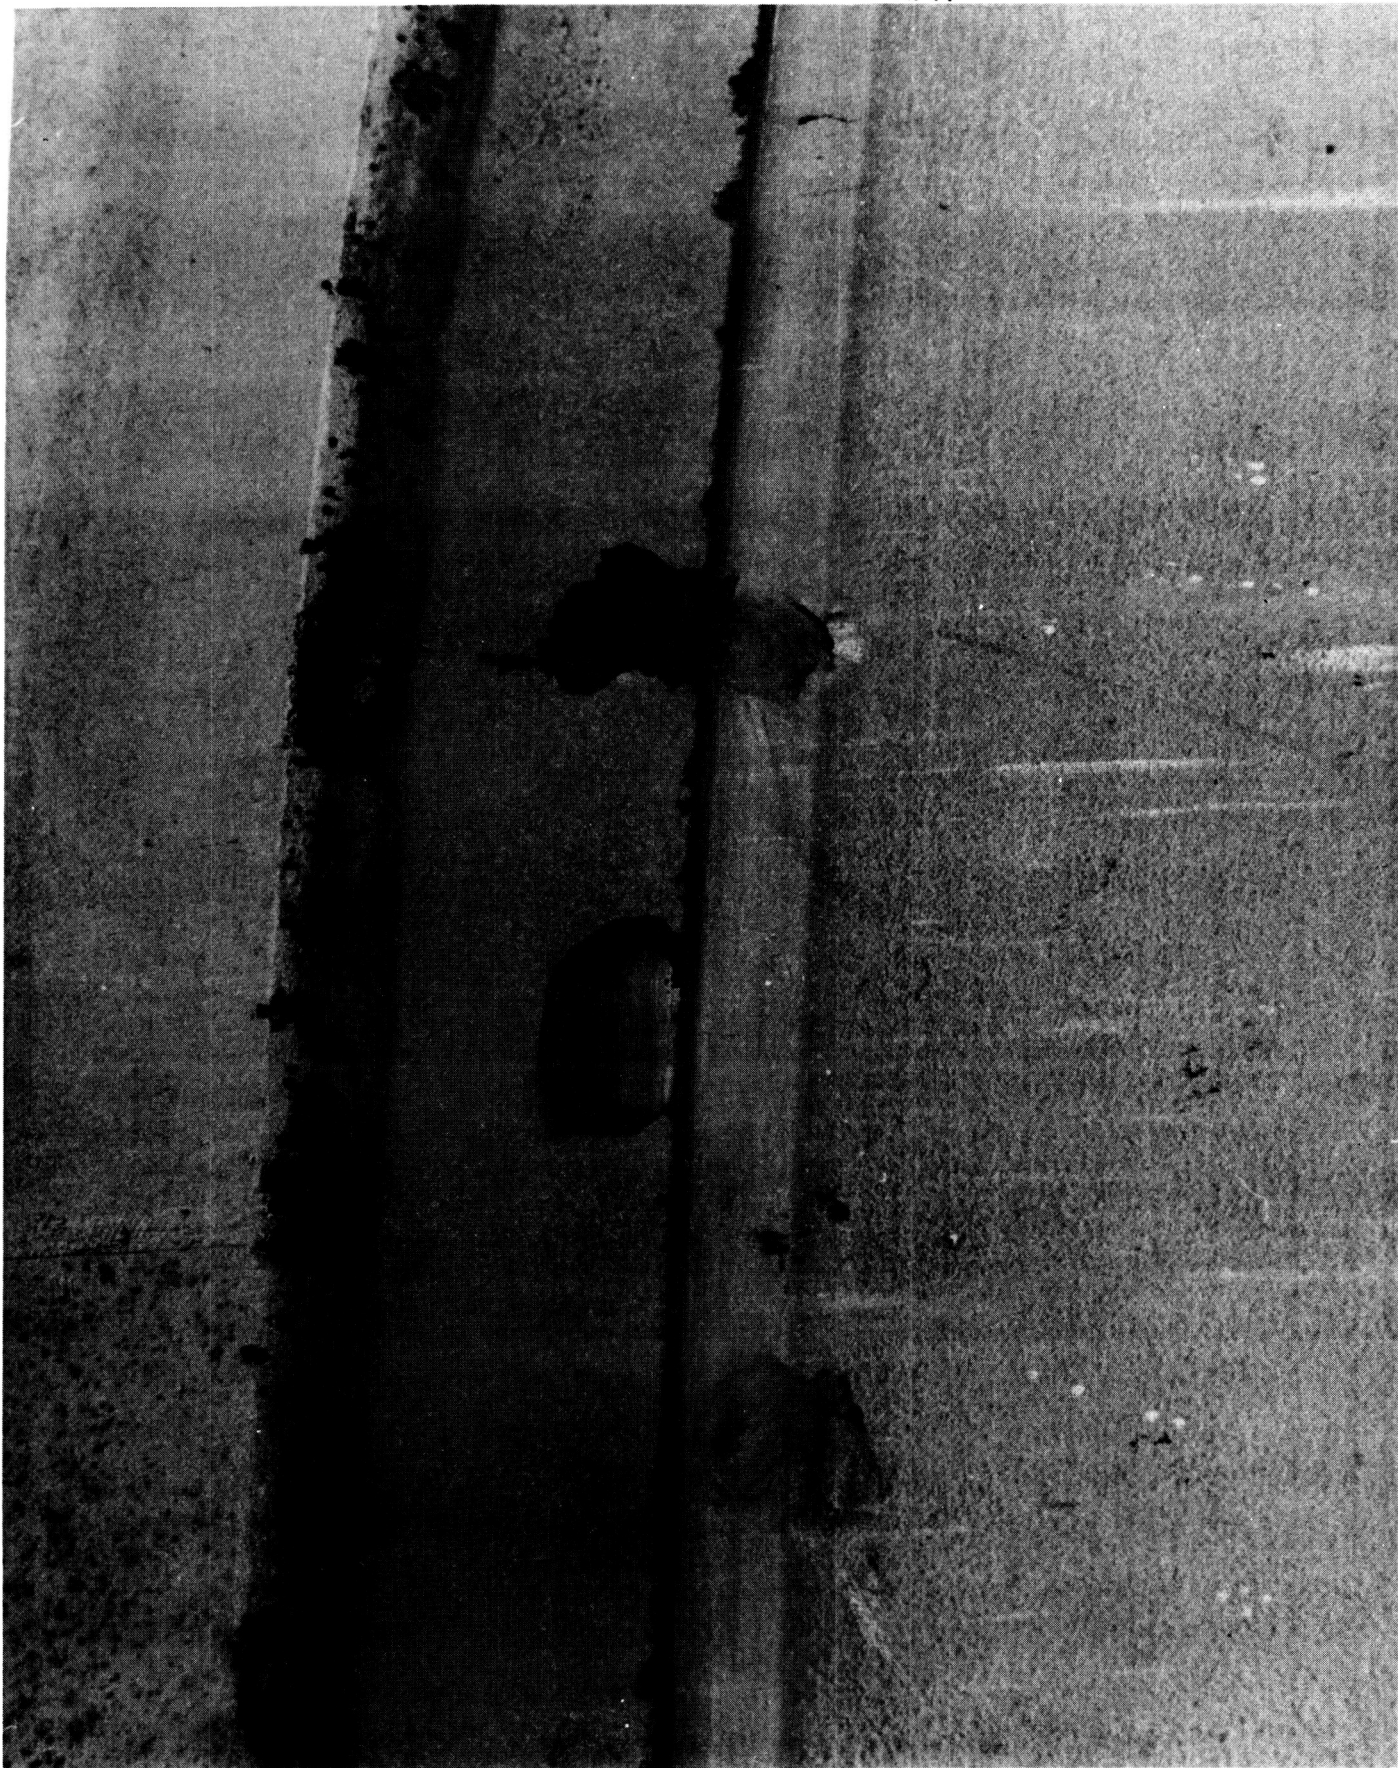
RIGHT DEI CORK DIVOT SHOWS SIGNS OF ASCENT AEROHEATING.
LEFT DIVOT SHOWS IMPROPER BONDING AND CAME OFF AT WATER IMPACT.

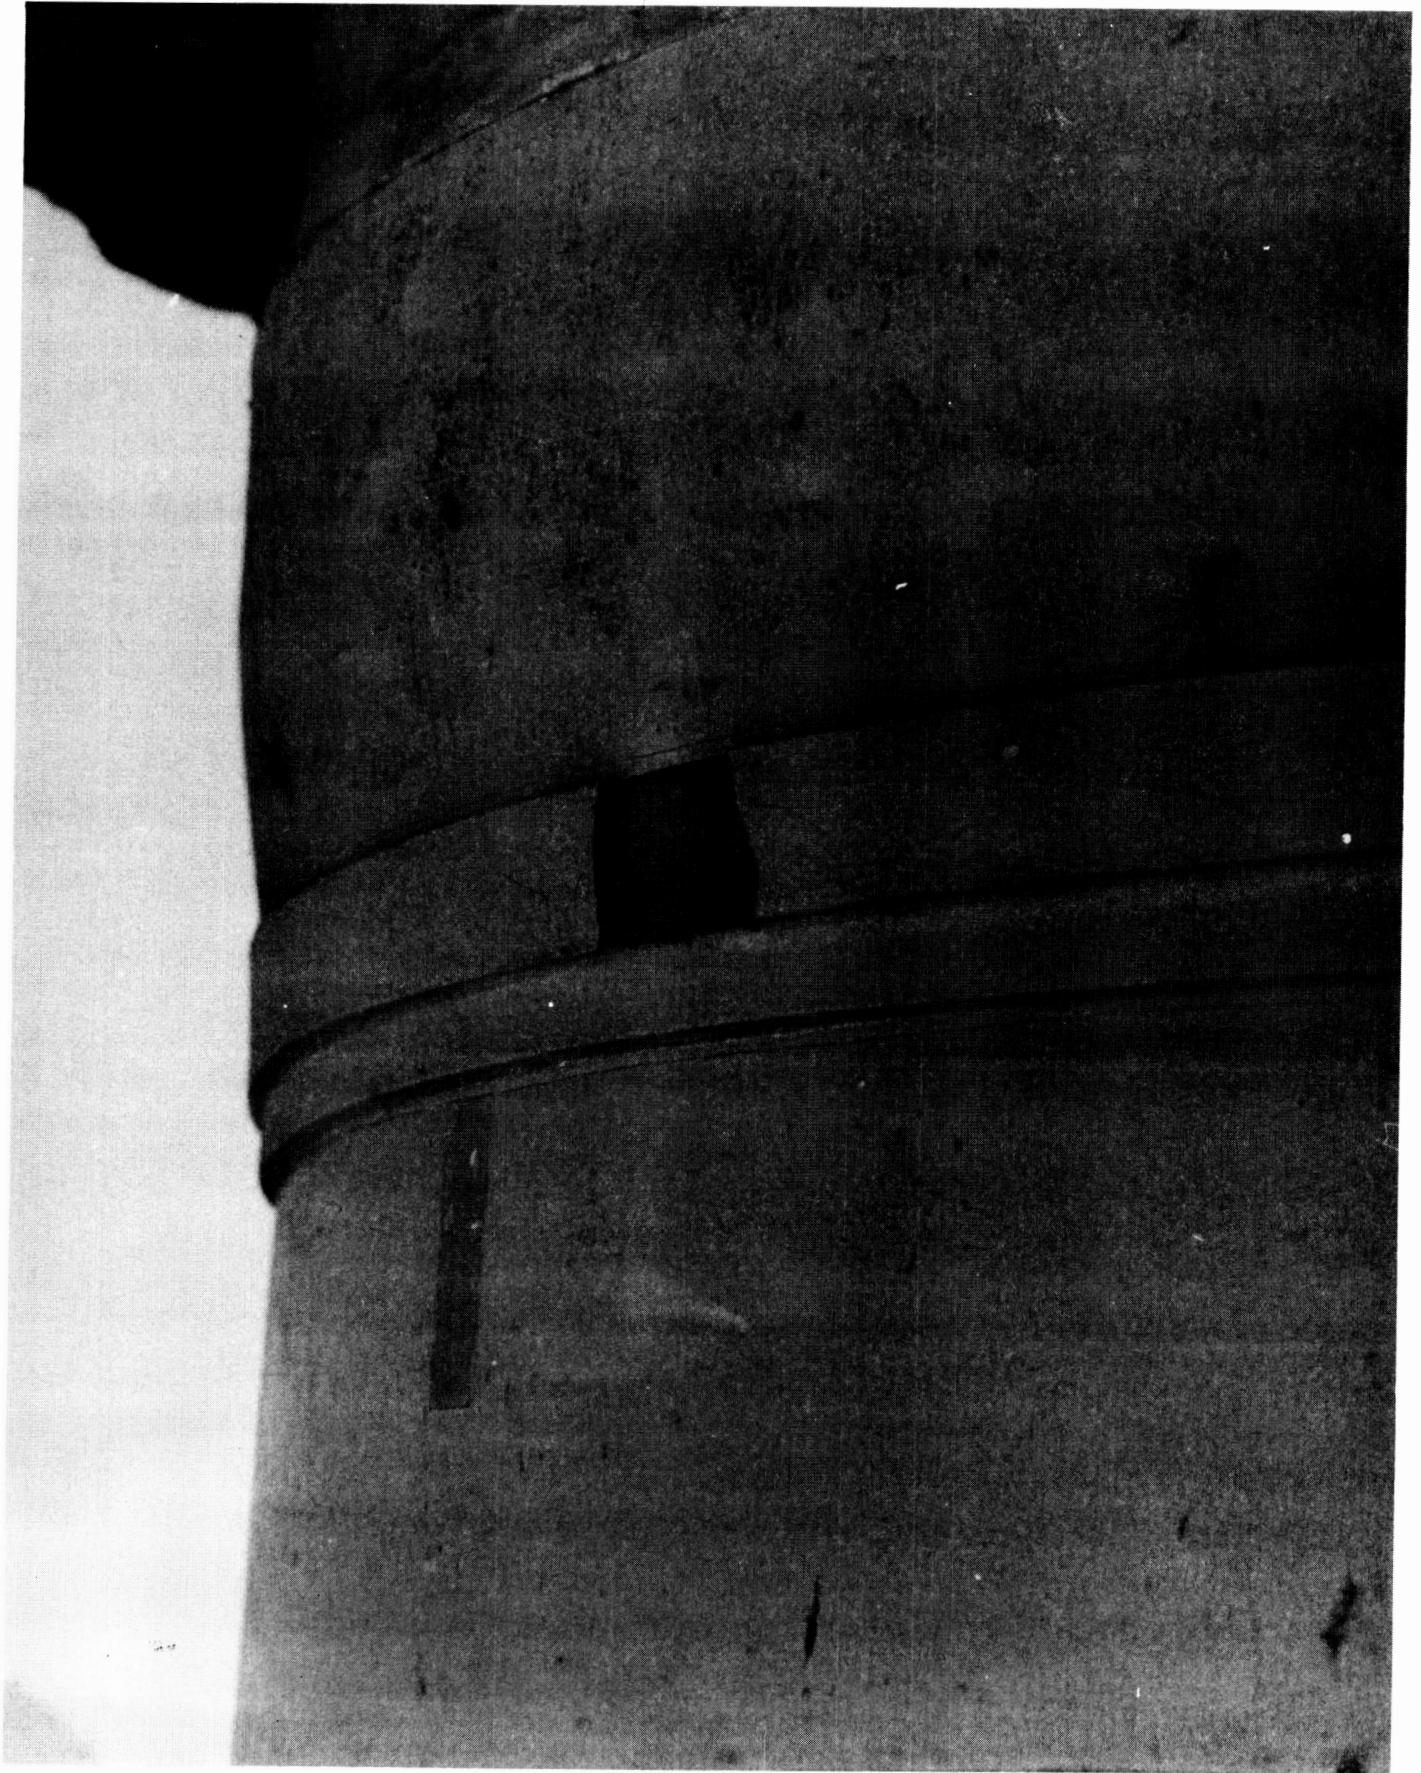
MISSING DFI CAP CORK FROM LH SRB AFT FIELD JOINT

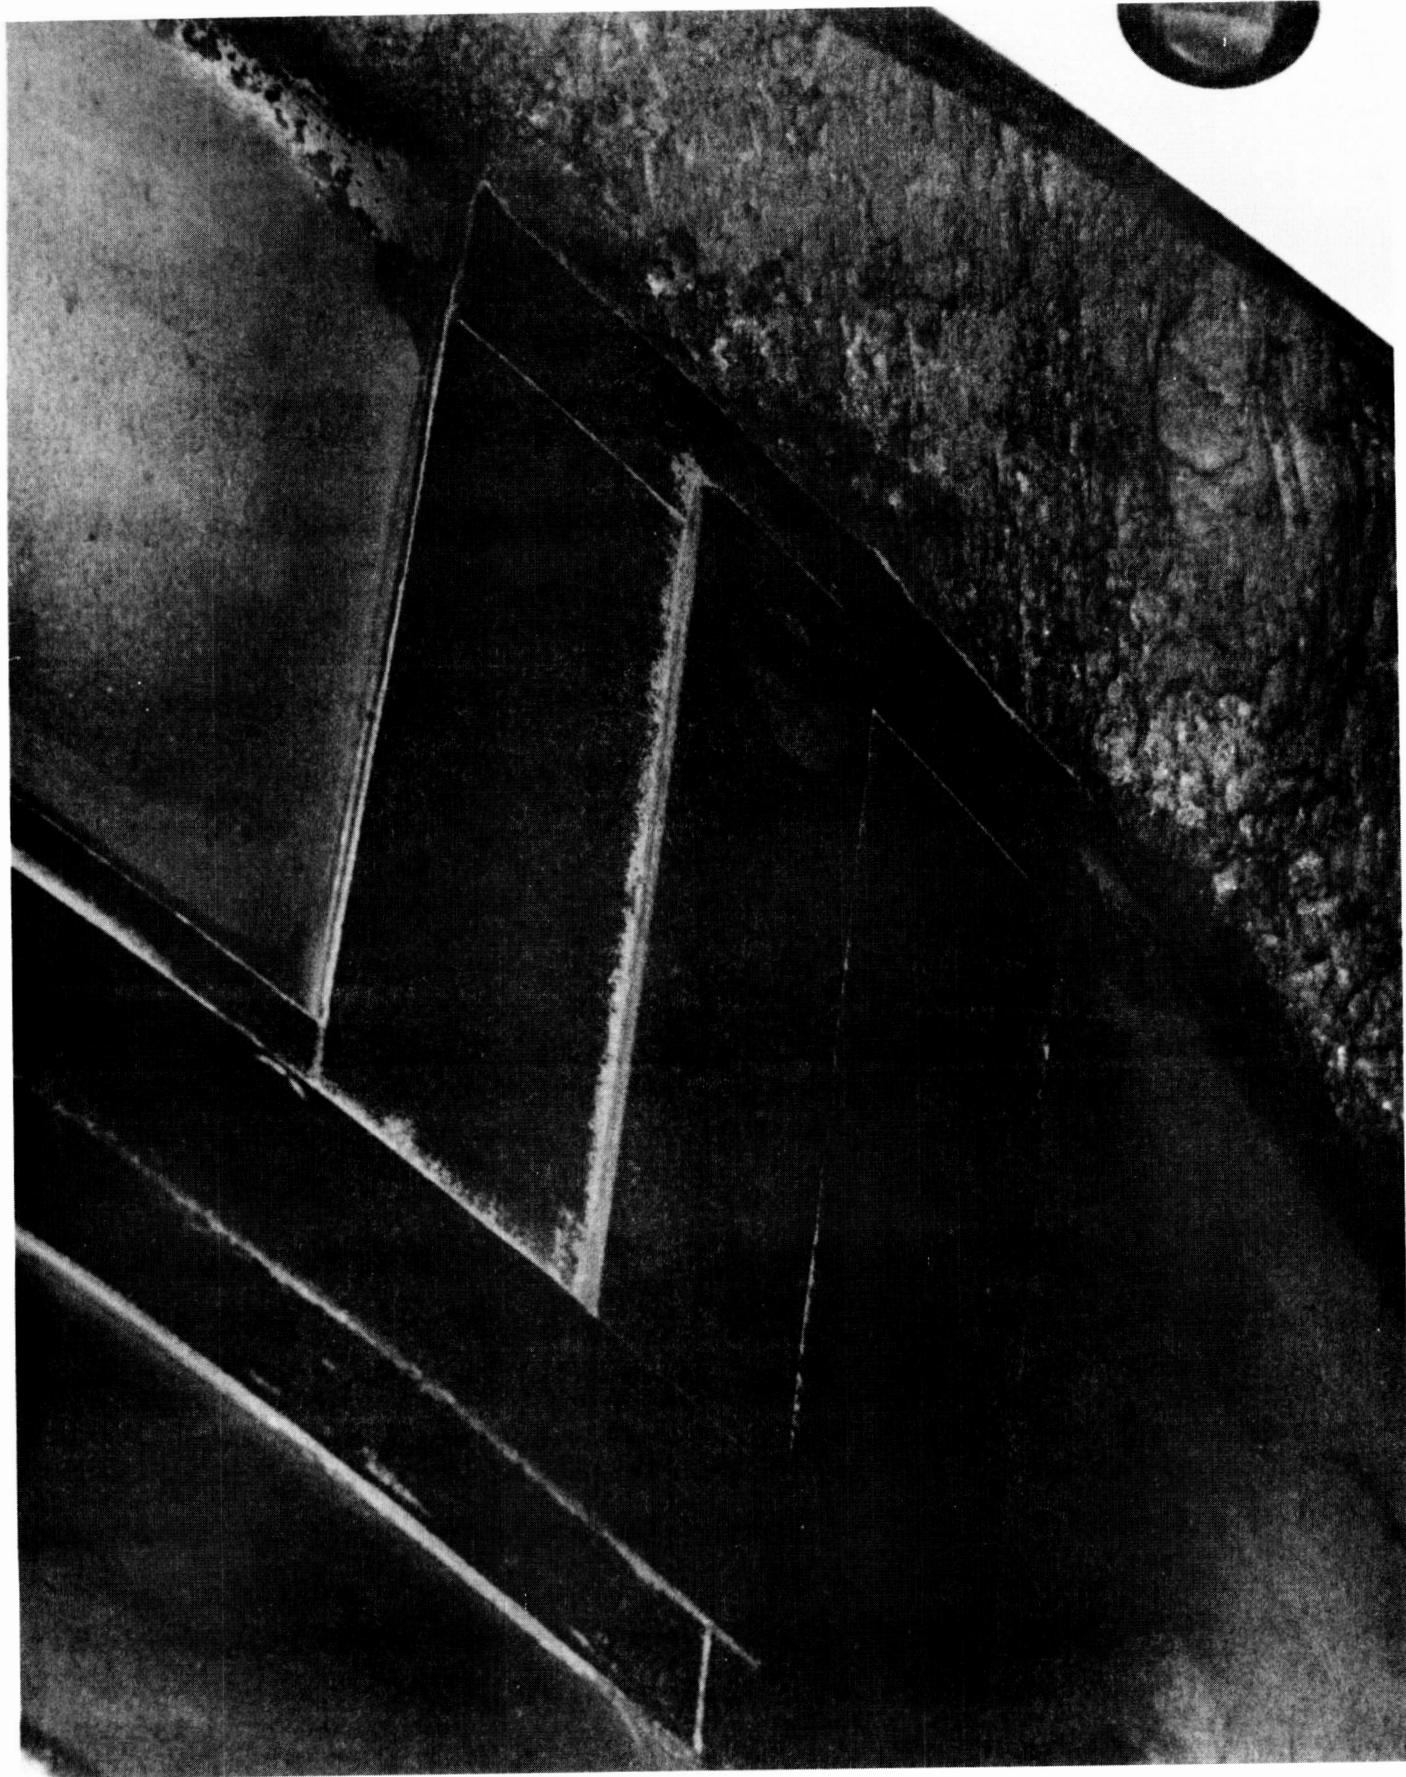
DIVOT IN DEI CORK ON RH AFT BOOSTER NEAR AFT FIELD JOINT

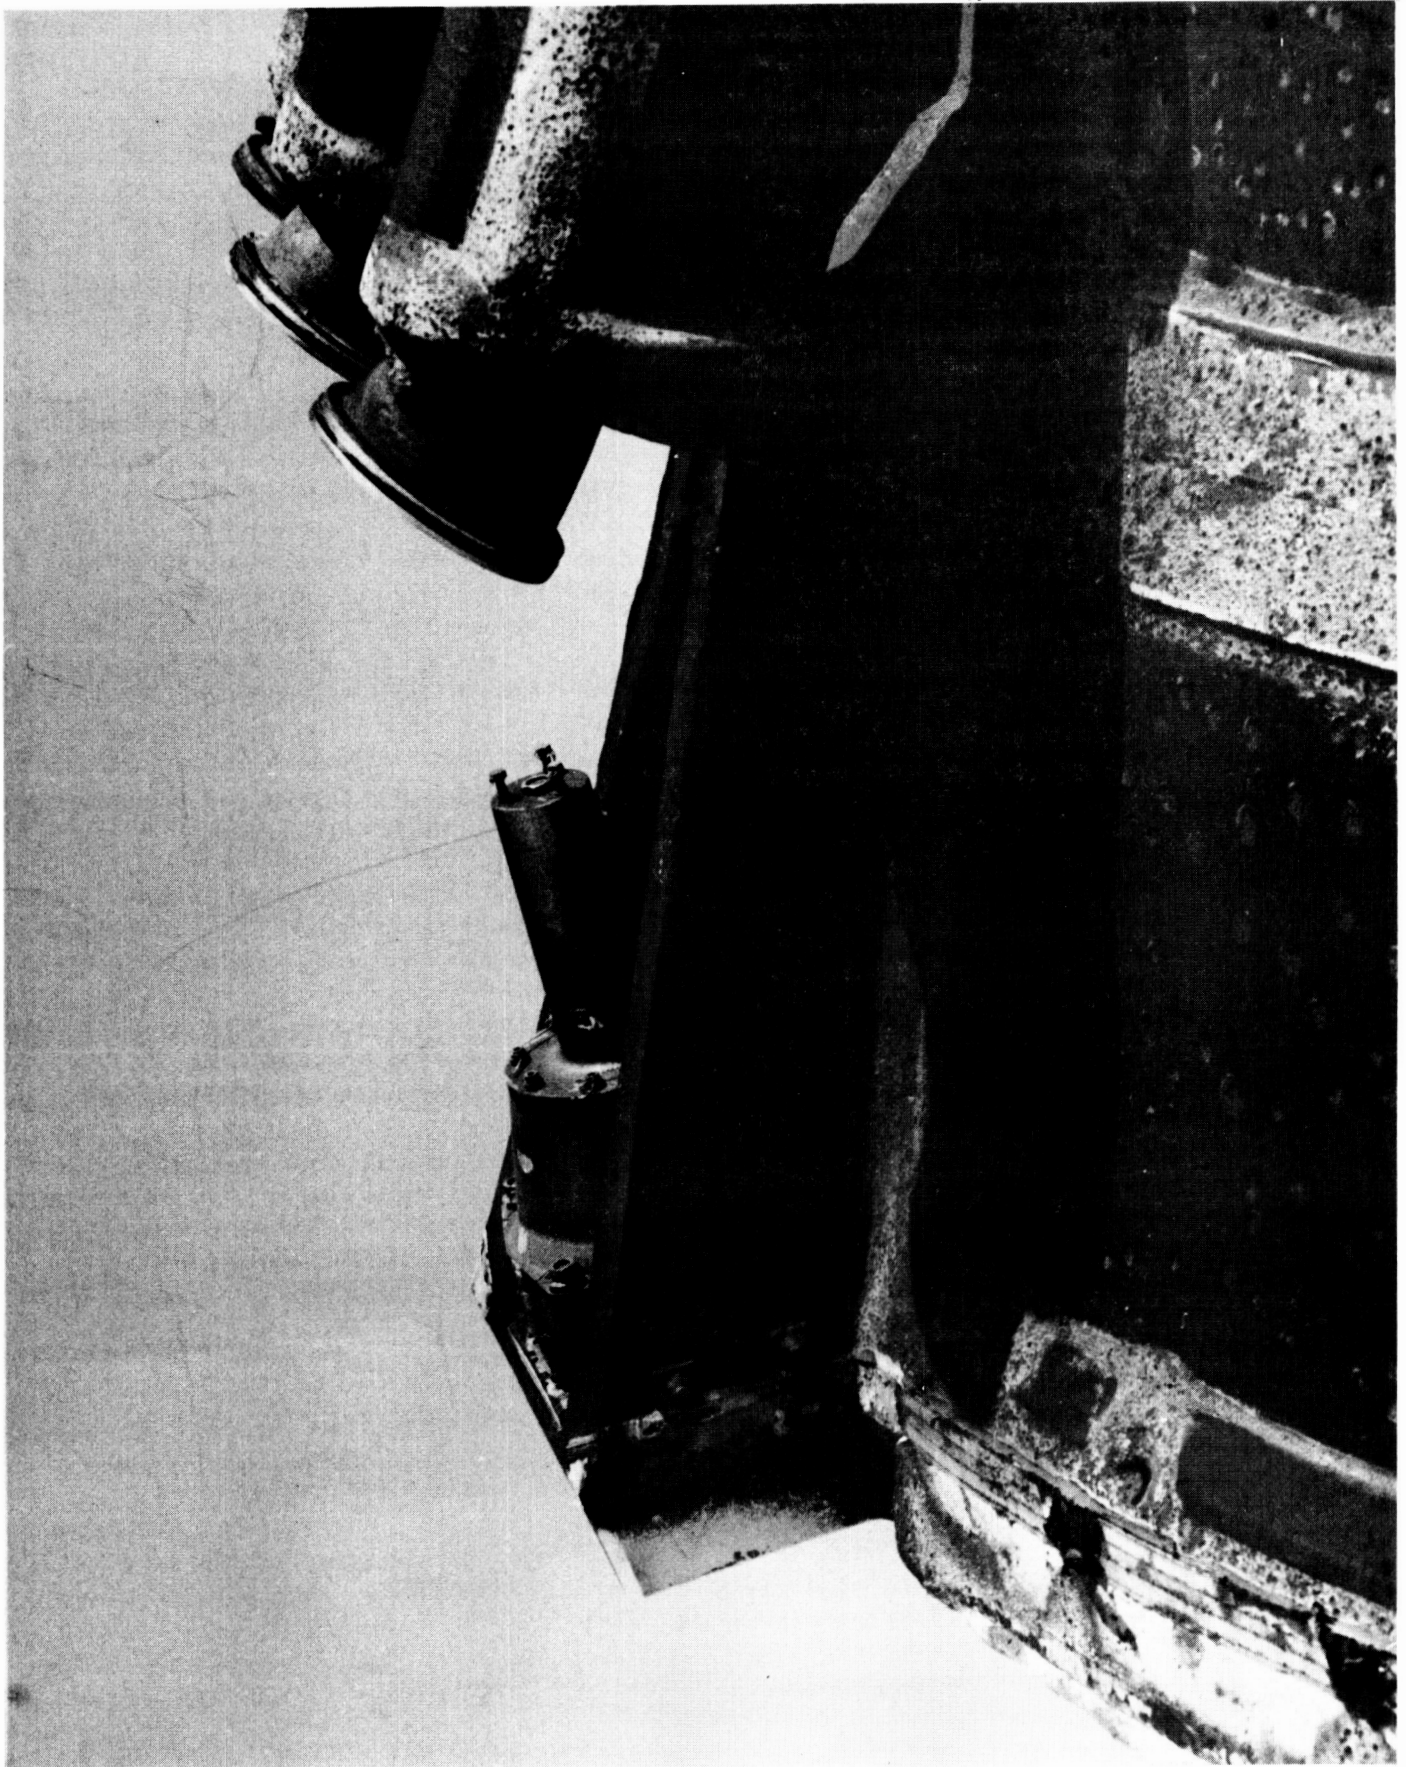
ALL AFT SKIRT DEBRIS CONTAINERS AND ATTACHING BOLTS WERE
INTACT. LOCKWIRE HAD MELTED OR BROKEN ON ALL +Z CONTAINERS.

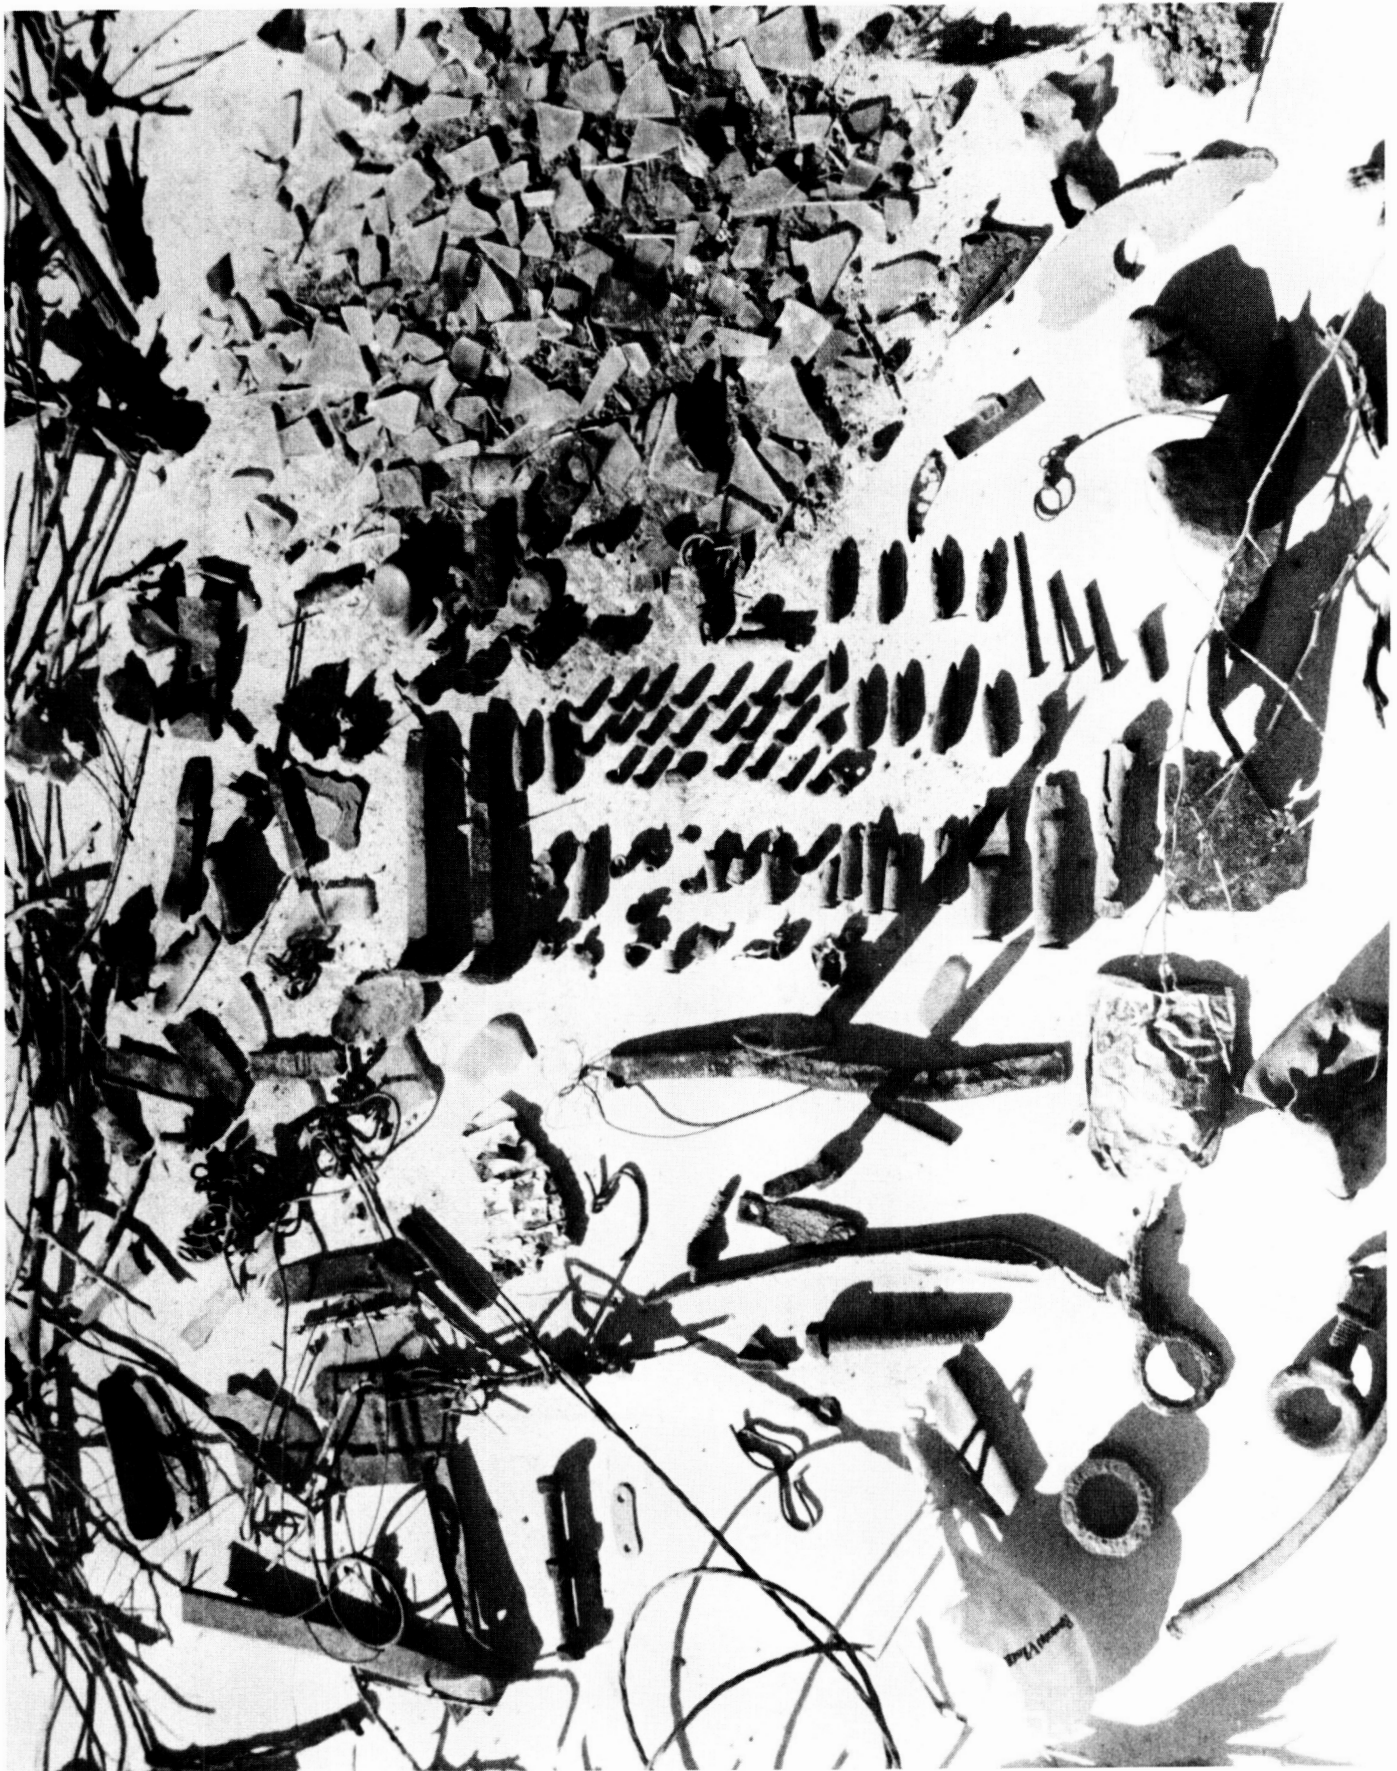
DEBRIS COLLECTED DURING PRE-LANDING RUNWAY INSPECTION
